# U.S. ENVIRONMENTAL PROTECTION AGENCY POLLUTION/SITUATION REPORT 2015 Gold King Mine Release SITREP

**Subject:** Situation Report #10

Gold King Mine Release San Juan County, CO

**Date:** 08/18/2015

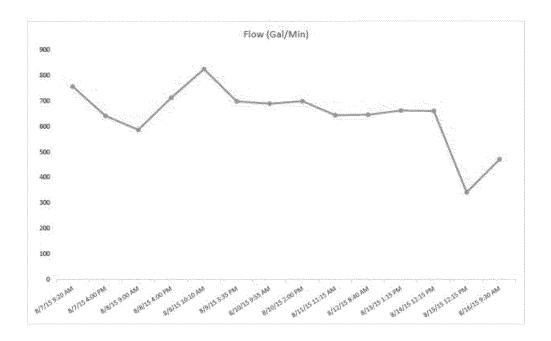
Flow from the mine through the morning of 8/16/2015 is shown in the following chart. **The flow at hour 1500 was 544 gallons per minute (gpm).** Treated water from the last treatment pond is discharging into Cement Creek. **The graph will be updated in the next SITREP.**
